Dam Site Visit
Taylor Pond Dam #245

8/17/92

Kendall Dam
Taylor Pass Dam File #245

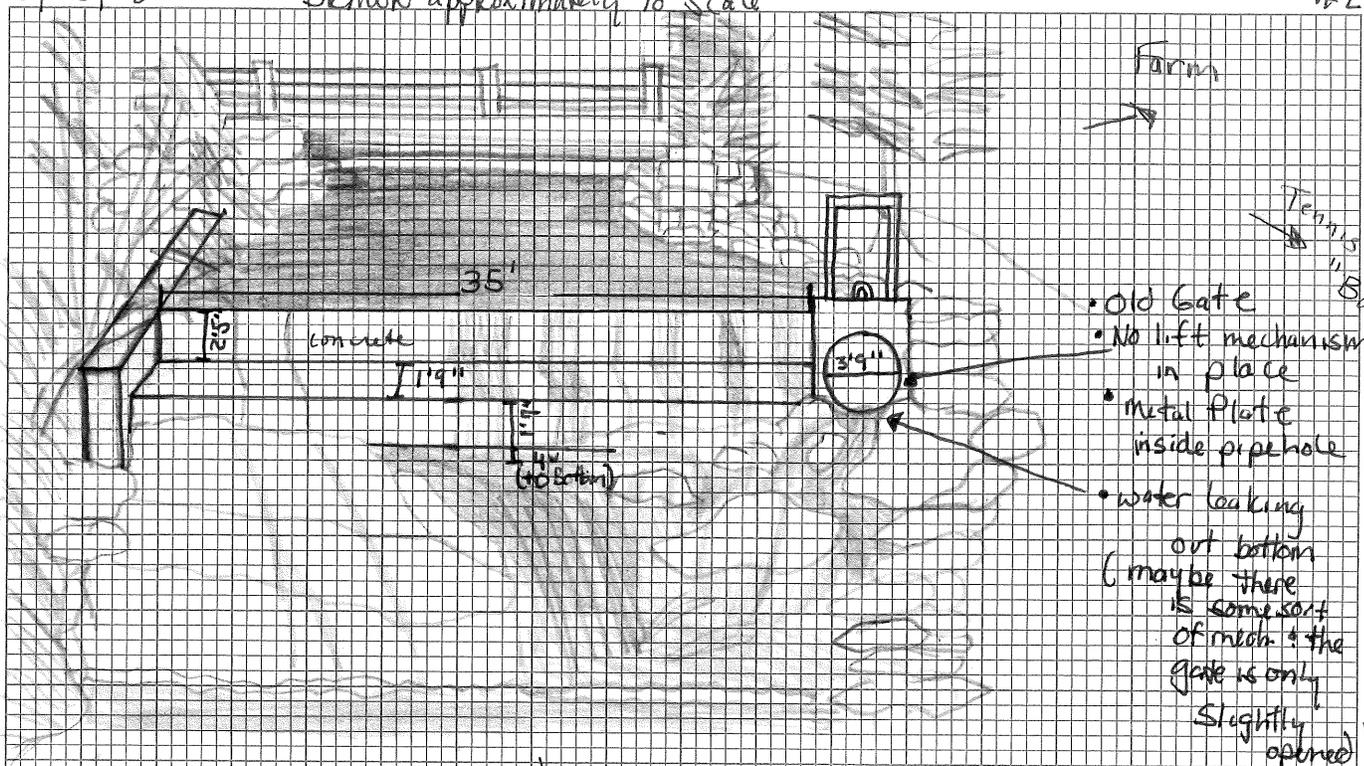
1st Dam

- Old Gate
- No lift mechanism in place
- Metal Plate inside pipe hole
- water leaking out bottom (maybe there is some sort of mech. & the gate is only slightly opened)

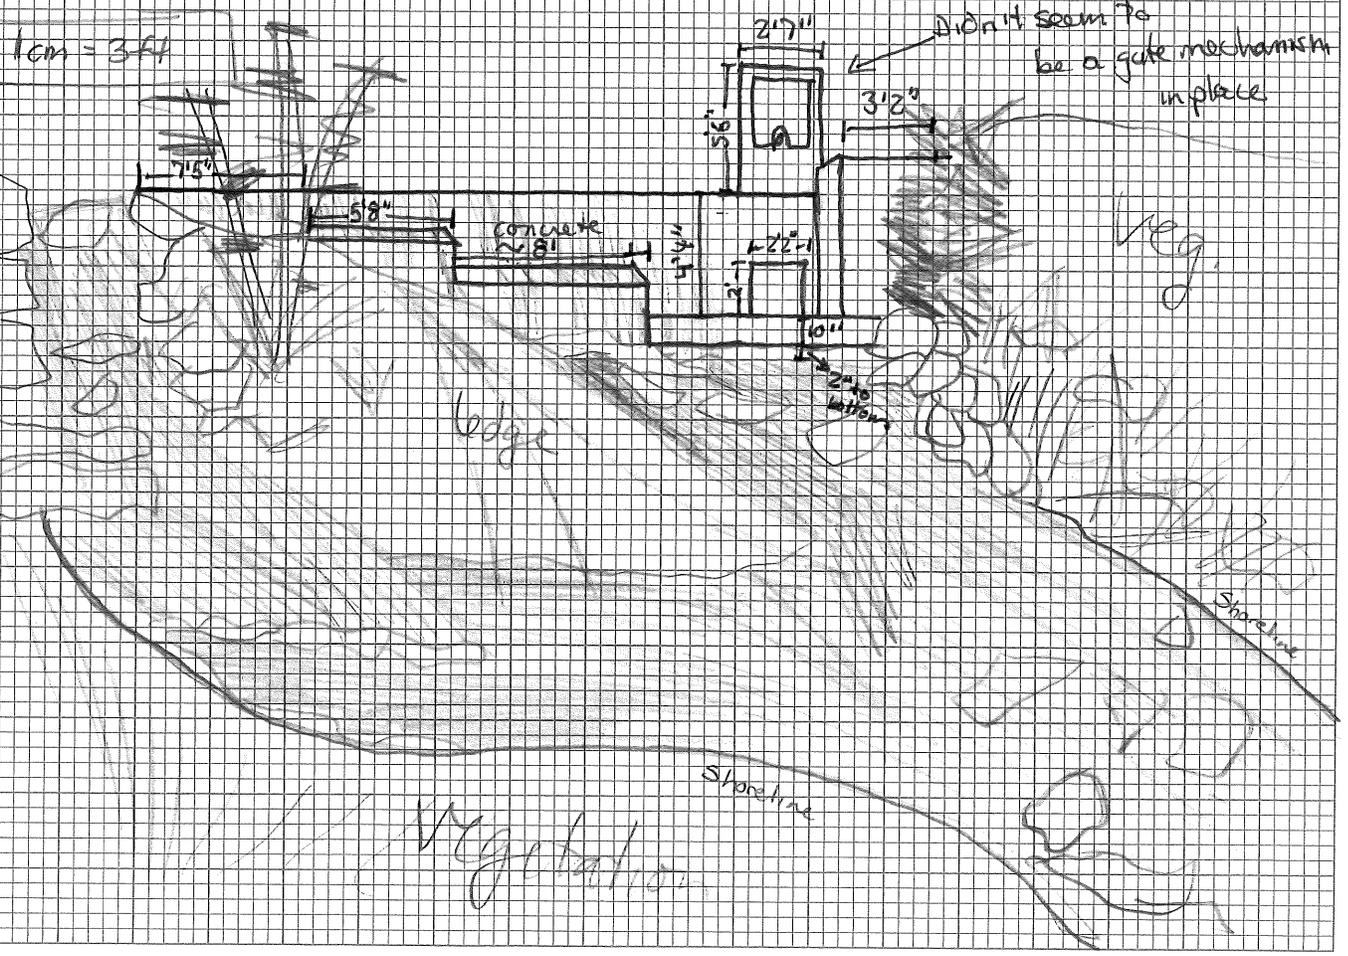
2nd Dam

Didn't seem to be a gate mechanism in place
