TECHNICAL MEMORANDUM

Project: Littlefield Dam Removal

Re: Existing Conditions Memo

This memorandum provides a brief assessment of the existing conditions at the Littlefield Dam Removal site.

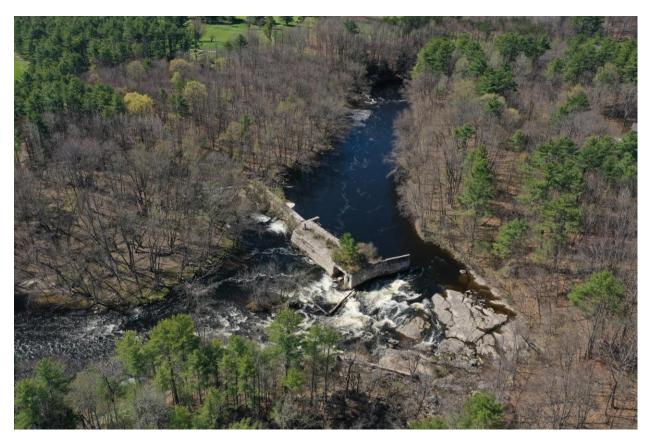
Figure 2. Drone photo of the Littlefield Dam. Photo taken May 1, 2025.

The extent of Littlefield Dam that remains in the channel is approximately 350 feet long and constructed of approximately 3,500 cubic yards of concrete. A photo of the Dam is shown in Figure 2 and the layout of the site is show in Figure 6. The concrete poor condition with widespread spalling. The Dam is currently breached on the river left and right side of the dam, with remnant structures associated with the Dam in the overbank areas on both sides of the channel. On the left there is an abutment that amounts to a minimal volume of concrete. On the right, there is a dam structure approximately 140 feet long which ties into an earthen berm connected to the hillslope. This masonry structure amounts to approximately 100 cubic yards of stone and mortar.

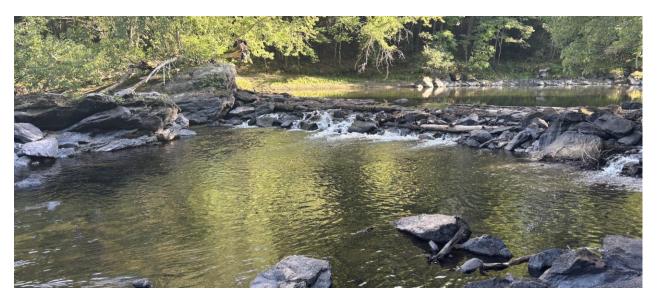
Figure 3. Looking upstream at the remnant dam. Photo taken August 28, 2025.

Approximately 750 feet upstream of the Dam, we discovered a remnant dam during the site survey (Figure 3). The timber and rock structure creates a drop of approximately 2 feet under low flow conditions. The remnant dam may present a fish passage barrier at low flow and is therefore being considered for removal as a part of the Project.

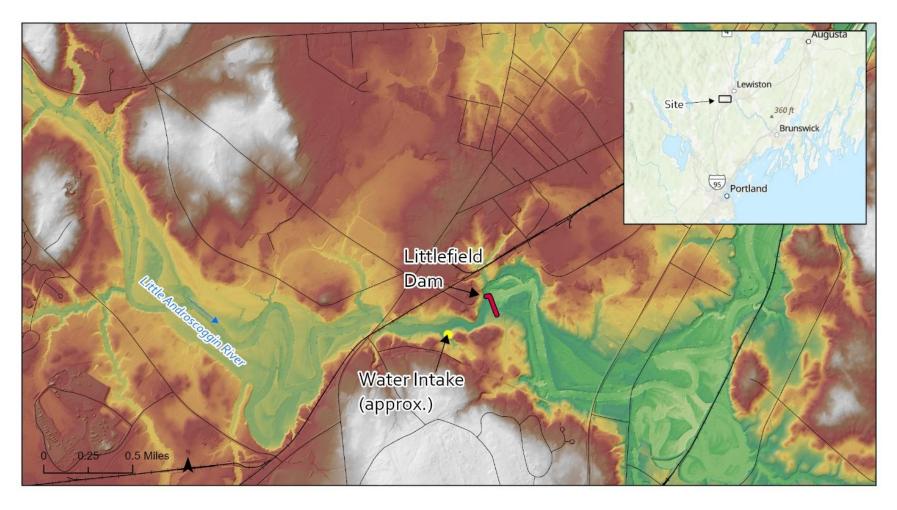
Figure 4. Lidar elevation model of the site and surrounding landscape. The steep and confined reach that the Dam sits along is apparent in contrast to the broad floodplain and meandering planform upstream and downstream of the site.

The Littlefield Dam sits at the downstream end of a steep and relatively confined reach of the Little Androscoggin River. This reach stands in contrast to the broad floodplain and meandering channel upstream and downstream of the site (Figure 4 and Figure 5). This localized steepness, known as a knickzone, is caused by the durable granite bedrock that underlies this section of river. Dams have commonly been located along knickzones to harness the increased energy of the stream and take advantage of outcrops of stable bedrock. This geomorphic context is important to consider during a dam removal. The abundance of ledge on the banks and bed of the river provides stability to the channel profile and planform, alleviating concerns over headcutting in the event of a dam removal. This eliminates a common challenge for dam removals, where channel adjustments post-removal can impact upstream infrastructure. However, when bedrock has been historically modified to enhance power utilization it may present challenges for fish passage following dam removal. The extent to which this is an issue won't be known until the dam is removed and will be addressed with an adaptive management approach.

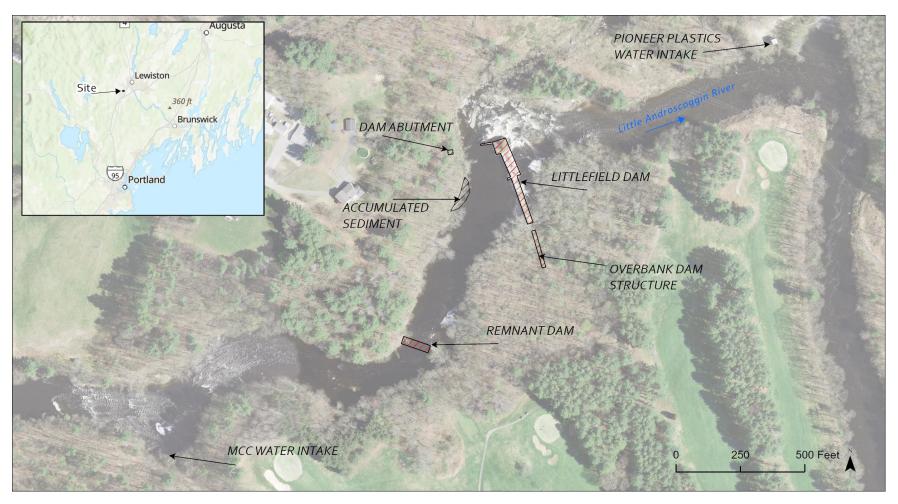
Figure 6. Aerial image of site with key features labeled.

velocities, resulting in low trapping efficiency. Additionally, very little sediment is delivered to the impoundment because the contributing watershed, like much of New England, yields very little sediment. The small pocket of sediment that was observed (Figure 6), was composed of sand.

There are water intakes upstream and downstream of the Dam (Figure 6). The water intake for irrigation at the Martindale Country Club is located approximately 1,300 feet upstream of dam. The Pioneer Plastics water intake is approximately 1,100 feet downstream of the Dam. Neither intake will be affected by the removal of the Littlefield Dam or remnant dam. The analysis supporting this finding is presented in the following sections.
