ADDENDUM NO. 1
TO
CITY OF AUBURN, MAINE
BID#2026-016
Removal or Demolition of 526 Minot Ave.
DATE: 3/10/26

**PRE-
DEMOLITION
HAZARDOUS
BUILDING
MATERIALS
SURVEY REPORT**

526 Minot Avenue
Auburn, Maine

Residential Structure

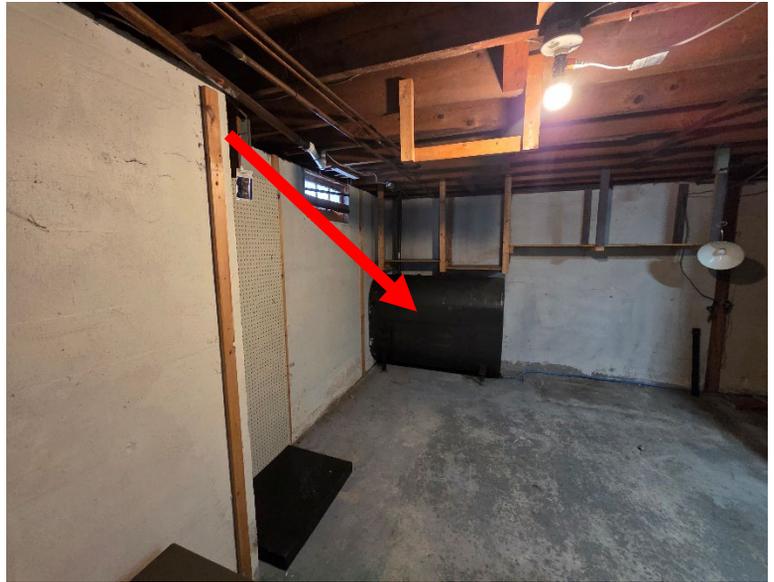
- A visual inspection for universal waste and other potentially hazardous materials identified items such as life safety equipment, various white goods and appliances, fluorescent lighting ballasts, mercury-containing equipment (e.g., fluorescent lamps, compact fluorescent light bulbs, and mercury switches) a home heating oil tank was observed in the basement.

HBM Oil Tank

Prior to demolishing the building, any hazardous materials or universal waste which are present should be removed from the building for reuse as specified by the owner, or for proper recycling or disposal in accordance with MEDEP solid and hazardous waste regulations (Chapter 400 and Chapters 850 through 858) as well as applicable federal and/or municipal regulations, codes, or guidance documents. Records documenting reuse, recycling, or disposal should be retained by the owner.

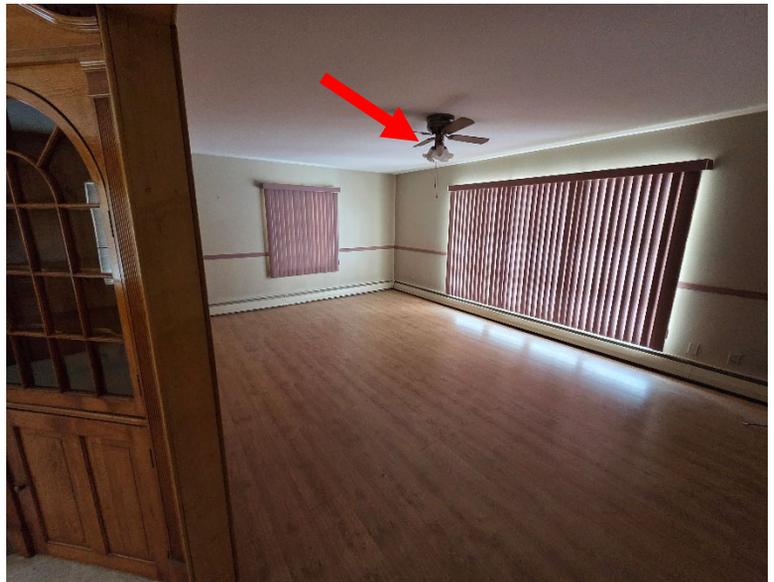
- Life safety equipment including smoke detectors.
- Fluorescent lighting ballasts: a percentage of equipment was inspected and found labeling on ballast indicating "No PCB". If the labeling is missing or not present on equipment, proper handling and disposal of equipment is warranted.
- Mercury-containing equipment includes fluorescent lamps, compact fluorescent light bulbs, mercury switches and other mercury containing equipment.
- Residential style Home Heating Oil Tank located in the basement.

HBM Standard Bulbs and Fixture

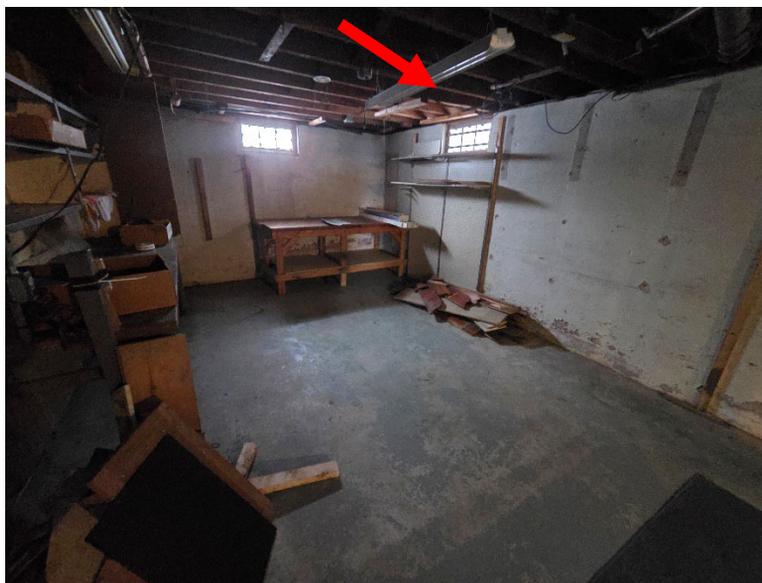
HBM Bulbs and Fixtures

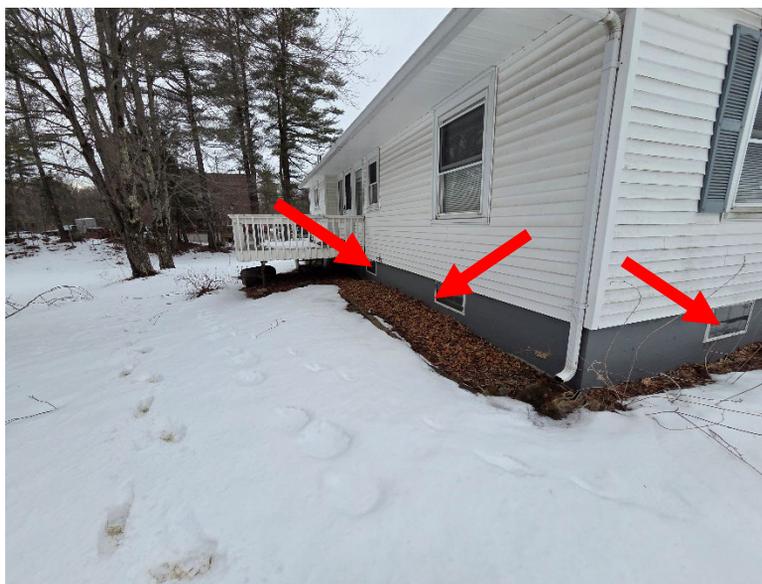
- Approximately 75 Square Feet of window glazing/caulking;
- Woven wire insulation on electrical systems could not be quantified due to live power being active and access limitations to the wire.

These ACMs describe above remain in good condition at the present time. However, if this material were to be disturbed during construction or demolition activities, such work would need to be conducted by a Maine licensed Abatement Contractor as discussed further below.

Presumed ACM Glazings/Caulkings

Demolition, construction and or renovation activities that disturb an ACM must be performed by a State of Maine licensed Abatement Contractor.

- A state of Maine certified Project Designer should prepare technical specifications for removal of identified and confirmed ACM.
- A state of Maine licensed Abatement Contractor should remove identified and confirmed ACM from the building prior to the start of demolition activities that may disturb the materials in accordance with federal, state, and local regulations.
