Dam Site Visit
Taylor Pond Dam #245

8/17/92

Kendall Dam
Taylor Pass Dam File #245

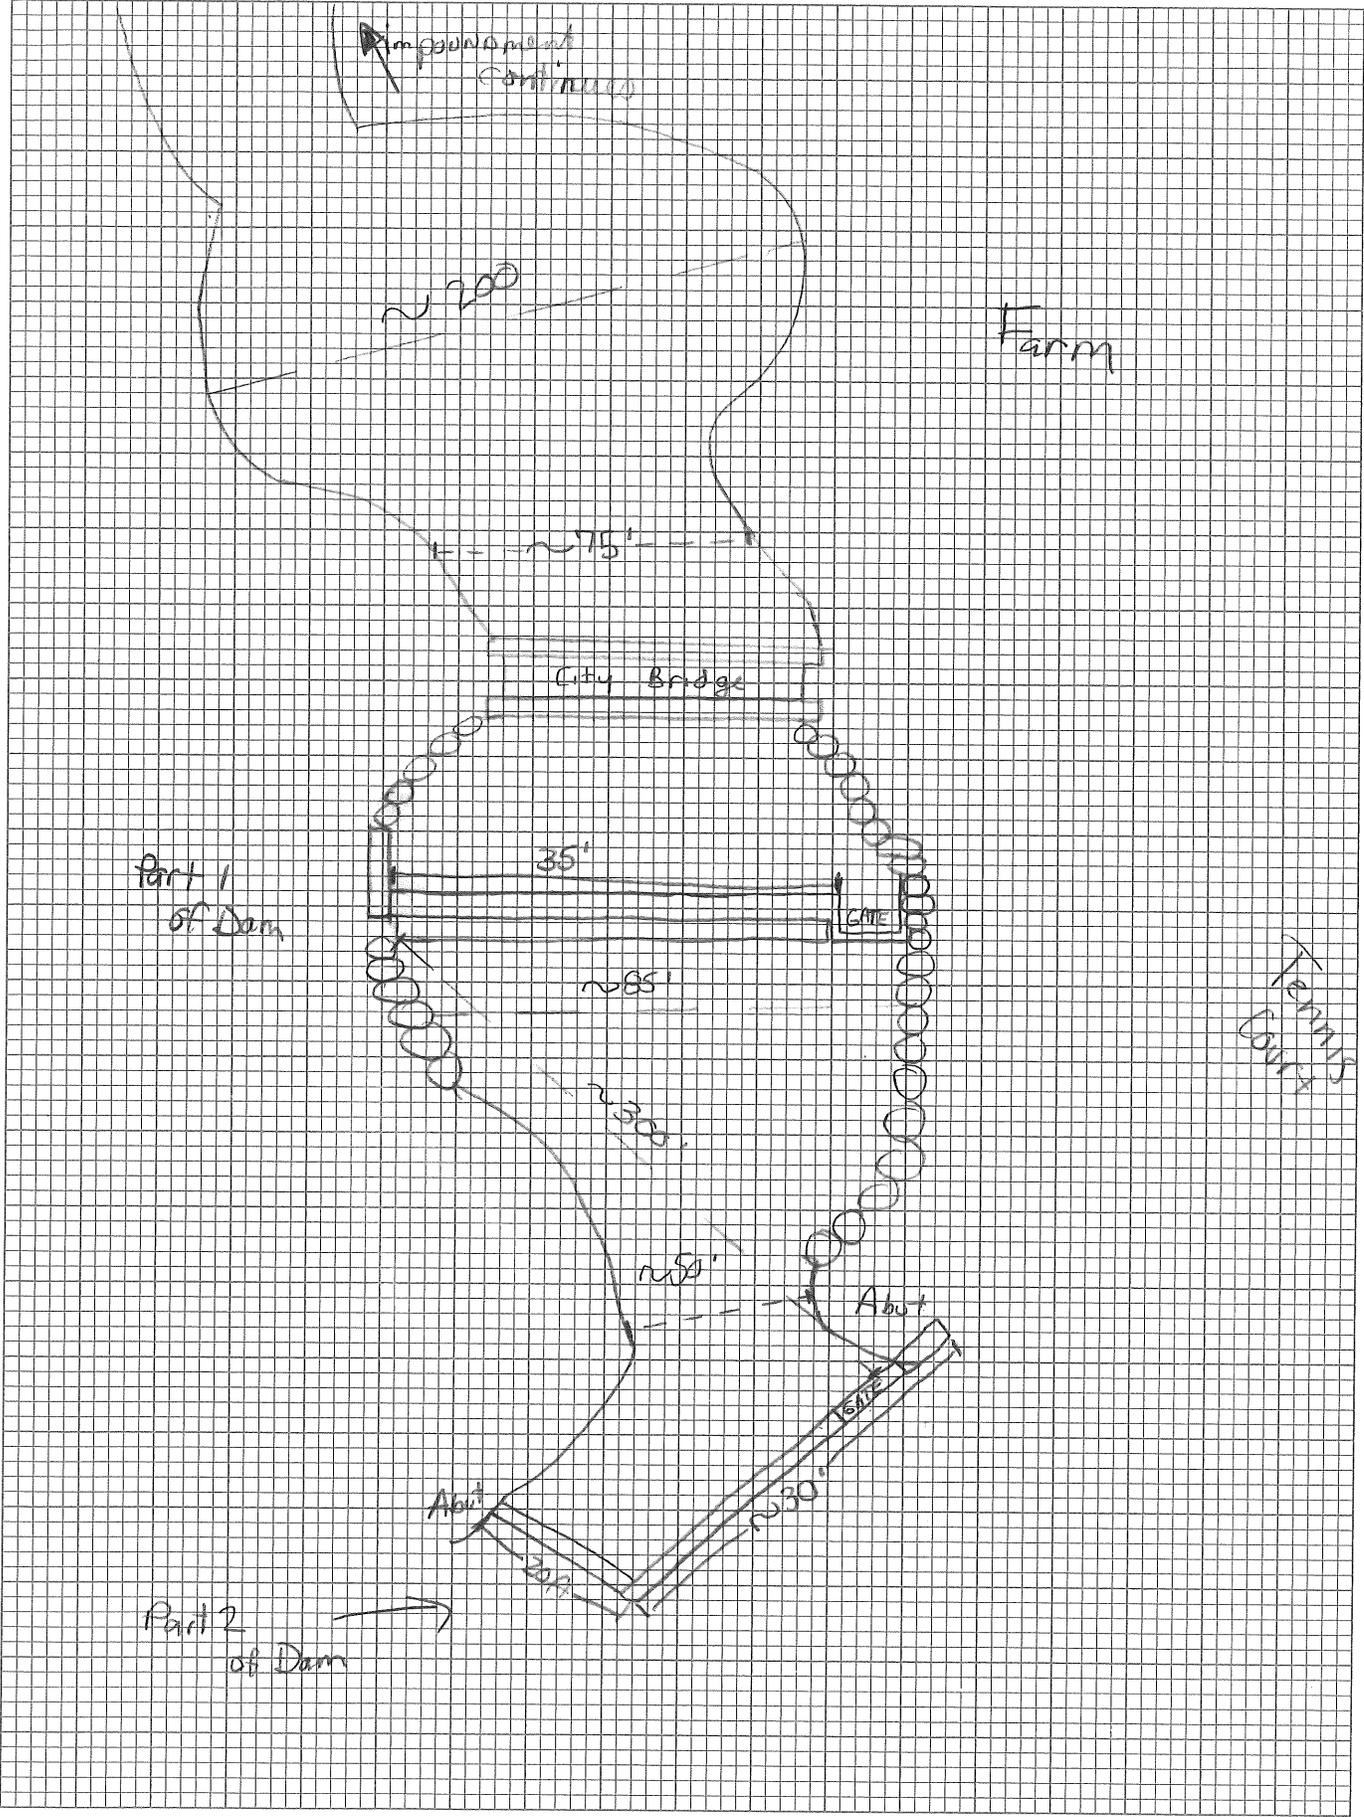
Taylor Pond F. 6 245

- Old Gate
- No lift mechanism in place
- Metal Plate inside pipe hole
- water leaking out bottom (maybe there is some sort of mech. & the gate is only slightly opened)
