TECHNICAL MEMORANDUM

Project: Littlefield Dam Removal

Re: Existing Conditions Memo

This memorandum provides a brief assessment of the existing conditions at the Littlefield Dam Removal site.

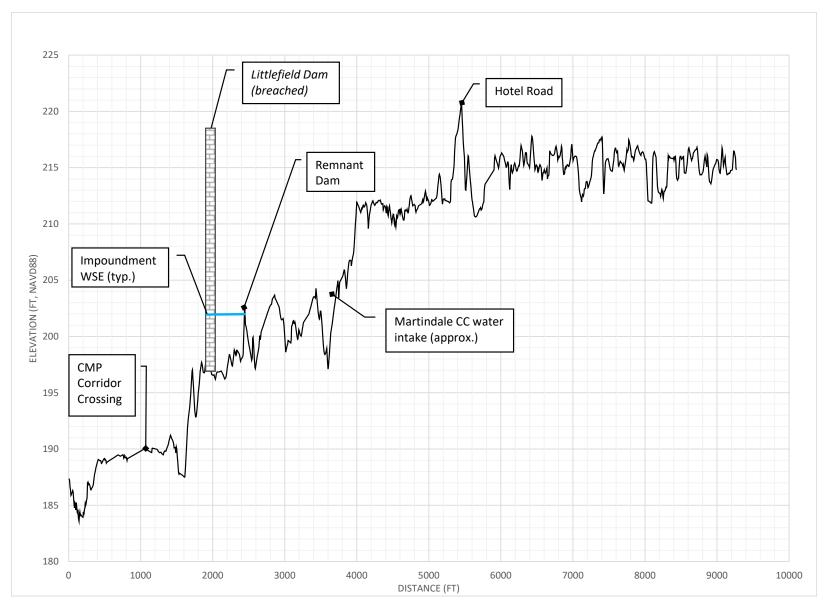
Figure 5. Lidar-derived longitudinal profile of the Little Androscoggin River.

The Littlefield Dam sits at the downstream end of a steep and relatively confined reach of the Little Androscoggin River. This reach stands in contrast to the broad floodplain and meandering channel upstream and downstream of the site (Figure 4 and Figure 5). This localized steepness, known as a knickzone, is caused by the durable granite bedrock that underlies this section of river. Dams have commonly been located along knickzones to harness the increased energy of the stream and take advantage of outcrops of stable bedrock. This geomorphic context is important to consider during a dam removal. The abundance of ledge on the banks and bed of the river provides stability to the channel profile and planform, alleviating concerns over headcutting in the event of a dam removal. This eliminates a common challenge for dam removals, where channel adjustments post-removal can impact upstream infrastructure. However, when bedrock has been historically modified to enhance power utilization it may present challenges for fish passage following dam removal. The extent to which this is an issue won't be known until the dam is removed and will be addressed with an adaptive management approach.
